## City of Fort St. John Stormwater Masterplan

Phase 1

April 29, 2013

**RE: FINAL REPORT – STORMWATER MASTERPLAN – PHASE 1**

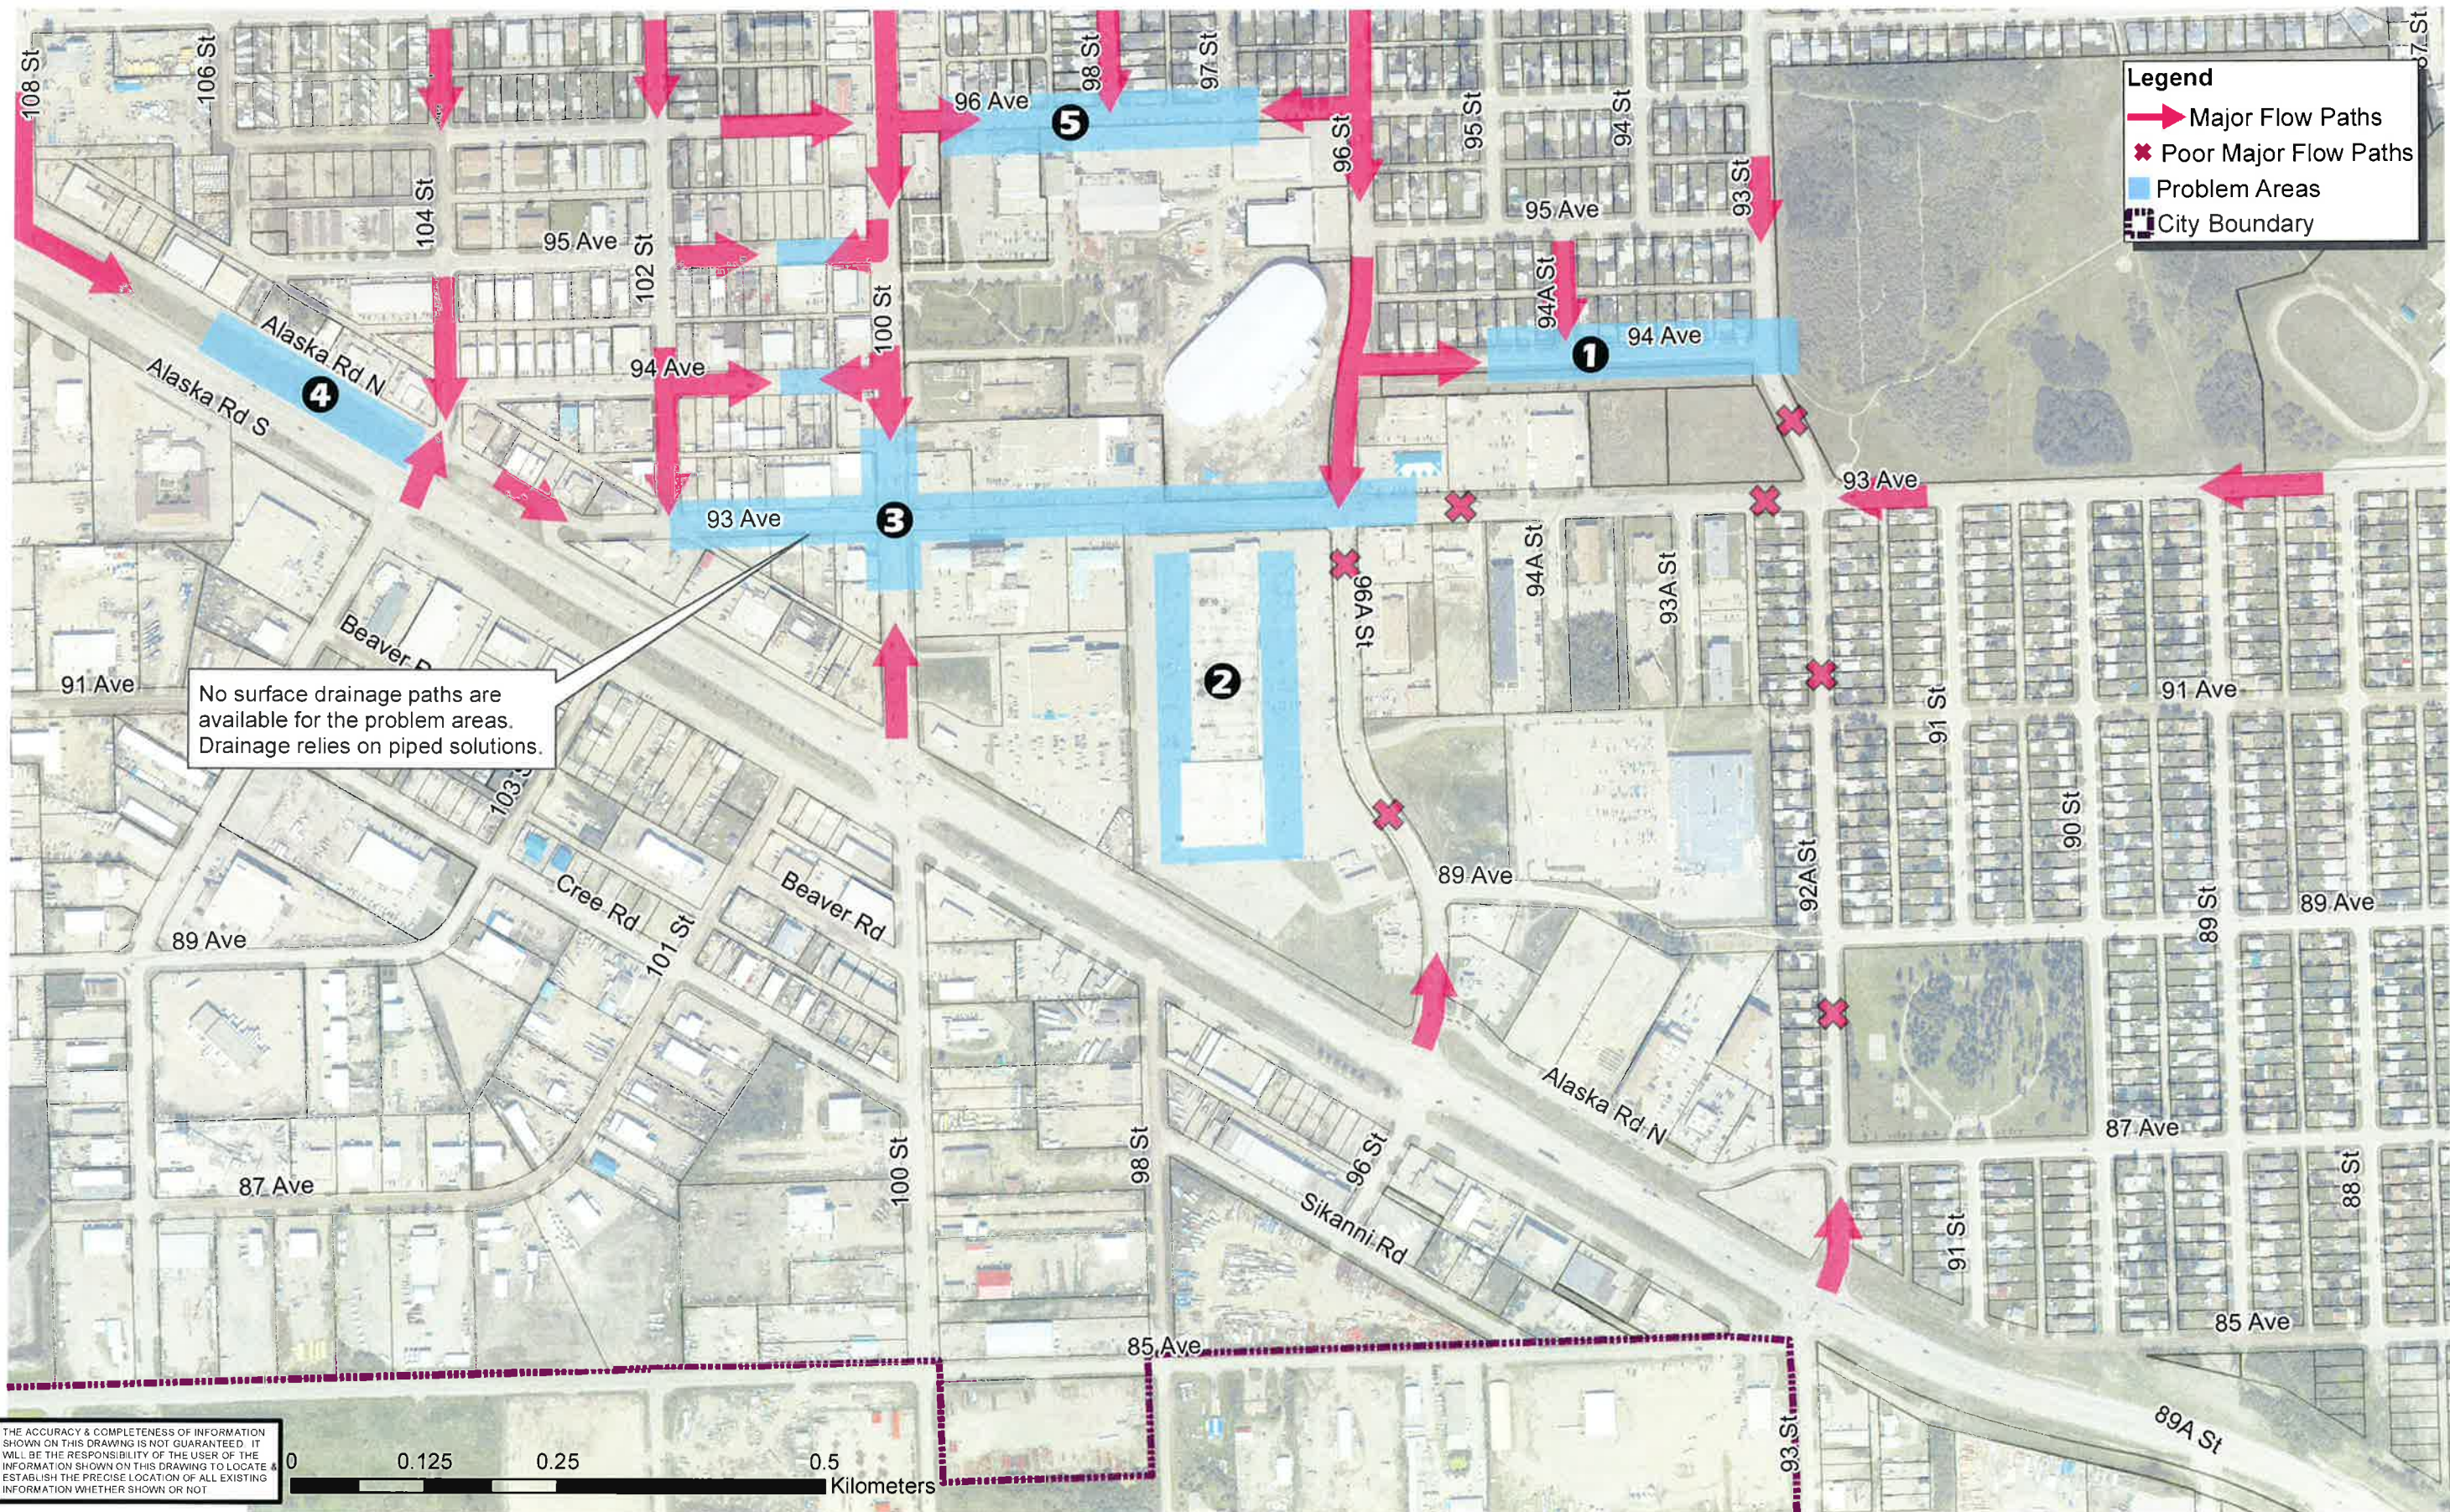
FIGURE  
**8**

**SOUTH-CENTRAL CATCHMENT  
DRAINAGE PROBLEMS**

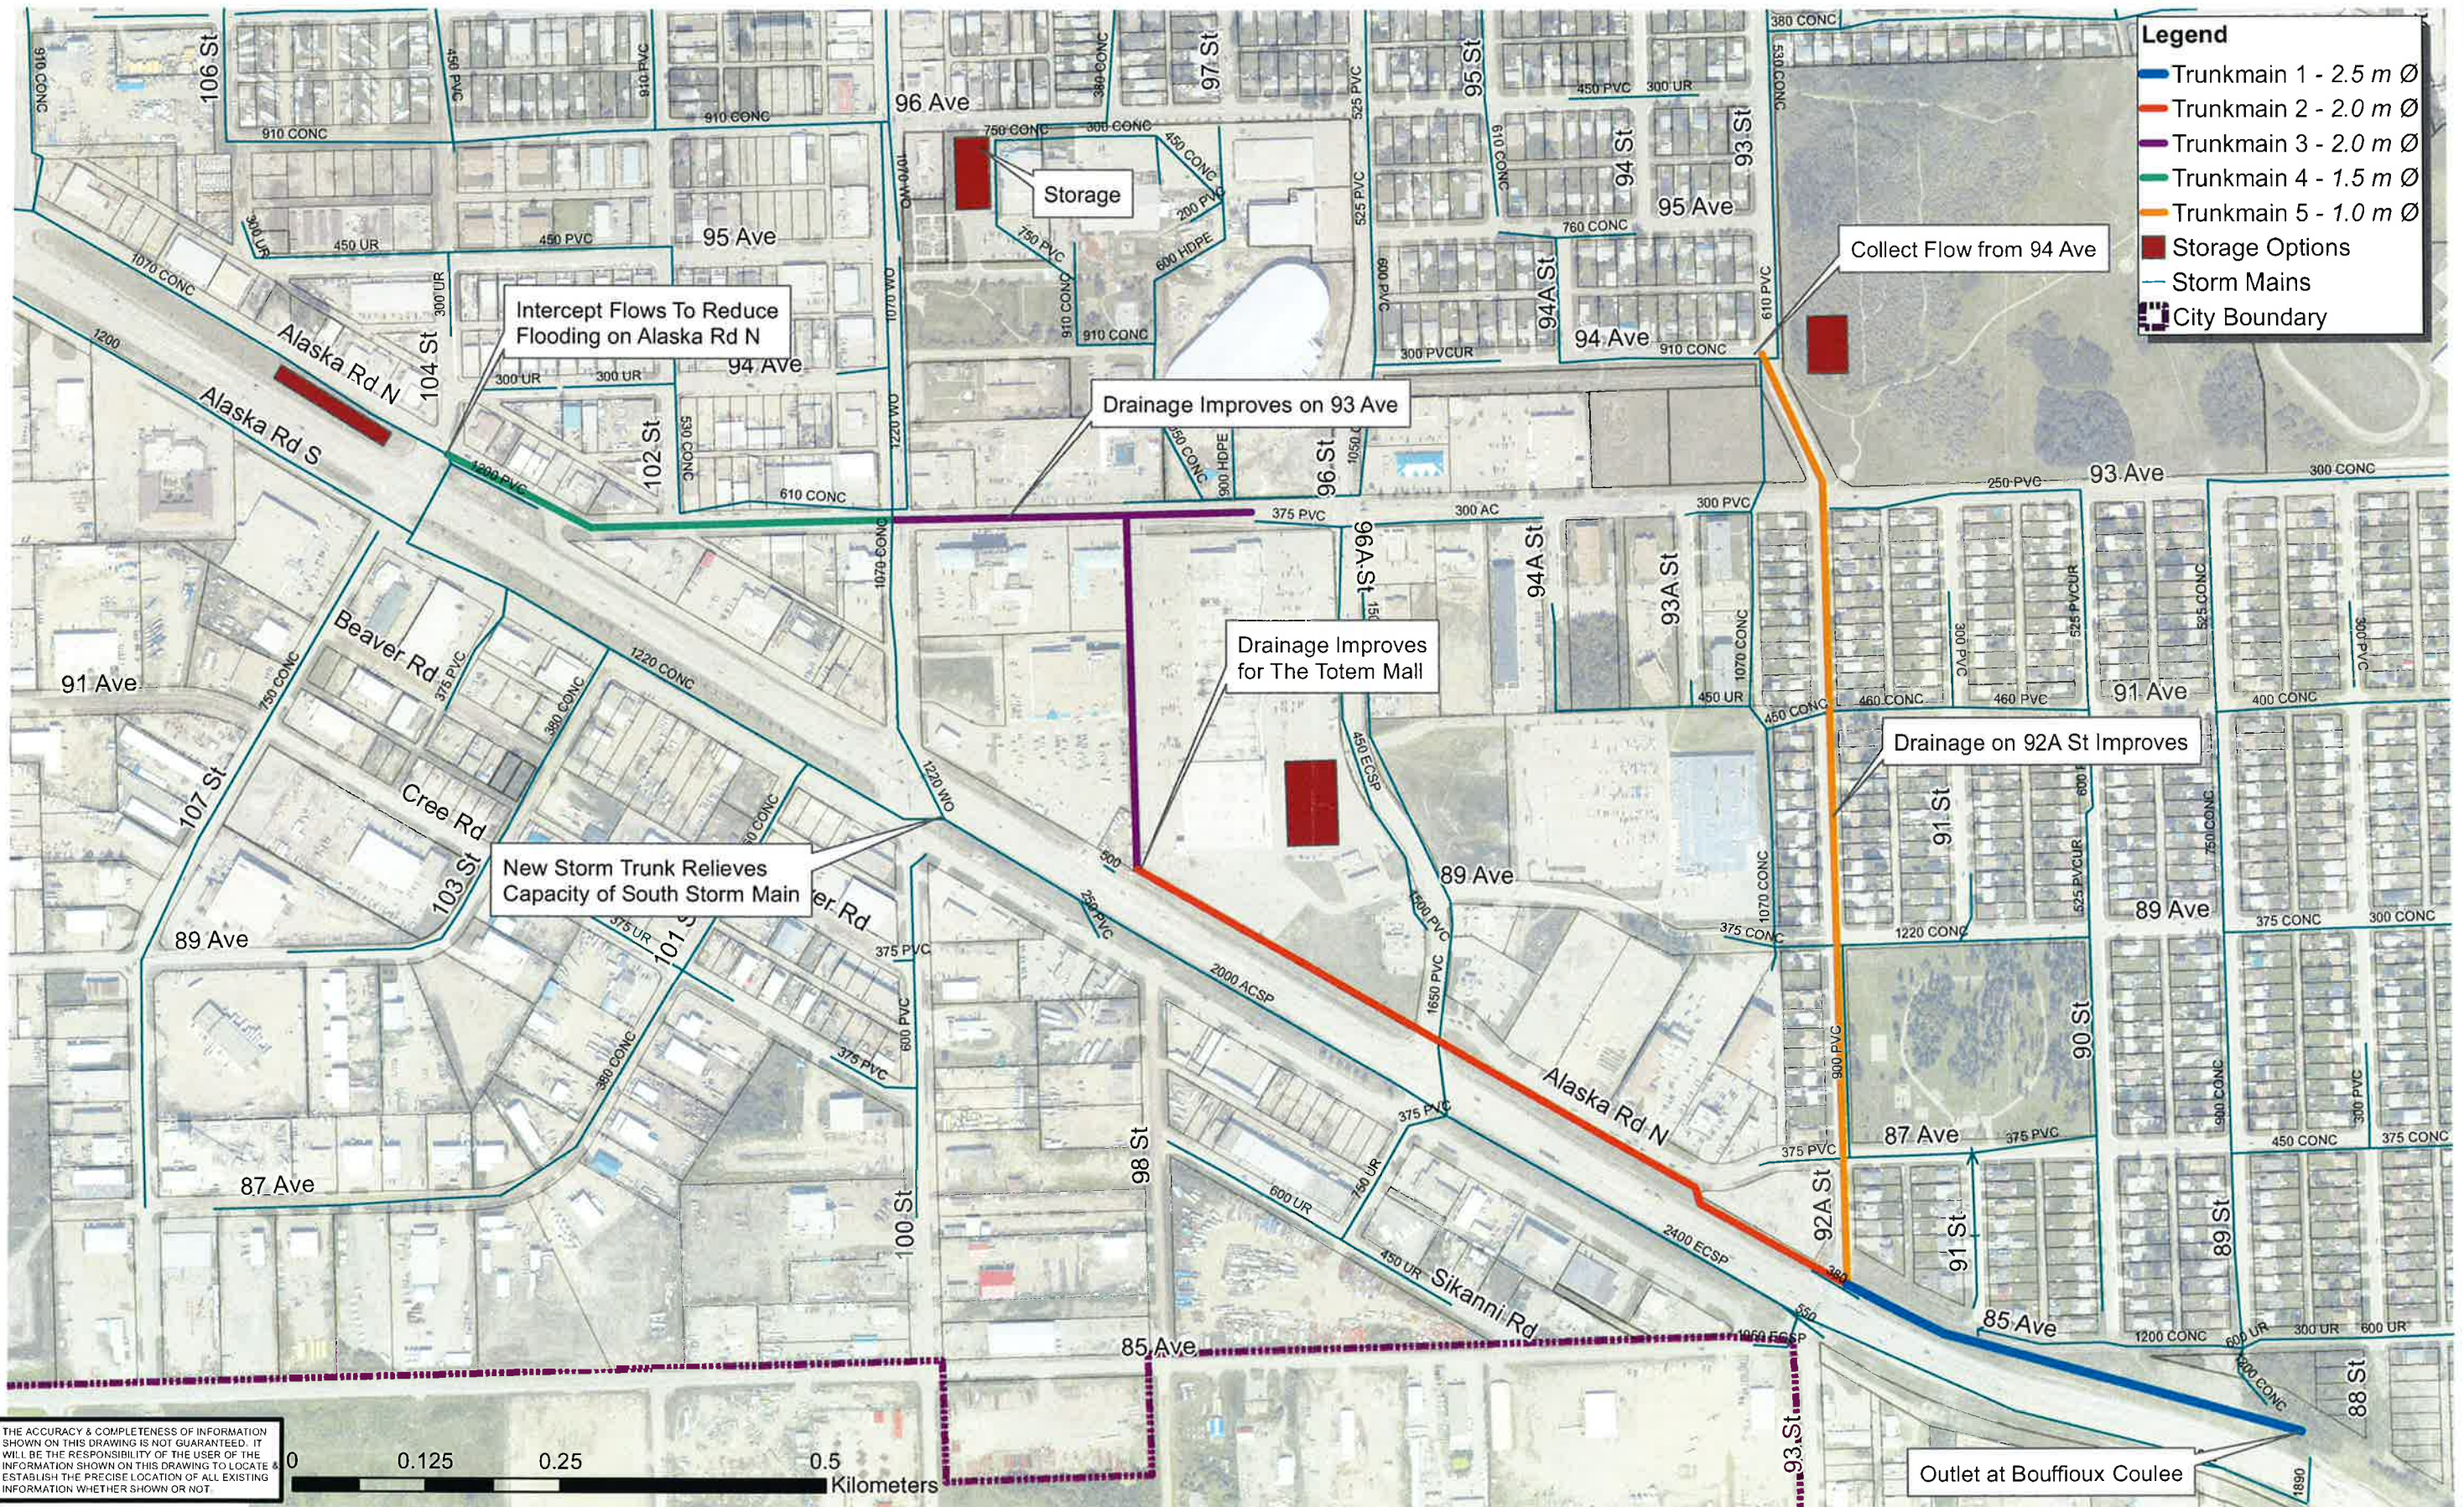
FIGURE  
**9**

# SOUTH-CENTRAL CATCHMENT DRAINAGE SOLUTIONS

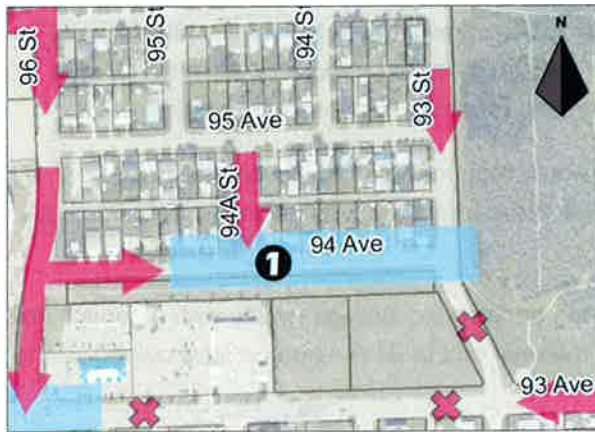
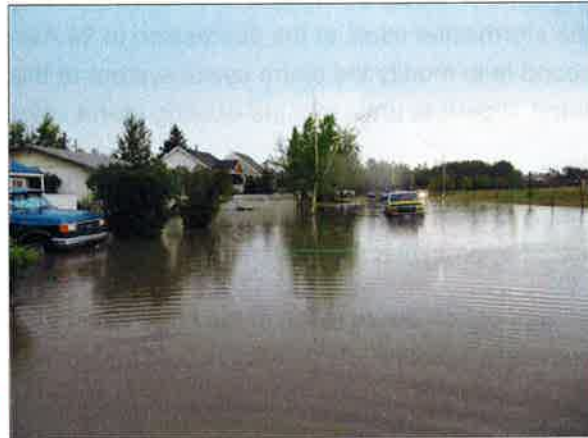
## 4.1 94 Avenue (96 – 93 St)

- The road surface of 94 Avenue is depressed between 93 Street and 96 Street and does not provide an overland flow route for runoff generated by significant and severe storms.

- Furthermore, the storm sewer system upstream of this location collects runoff from higher elevations and generates considerable head while under full conditions. Manholes/CBs may surcharge at 94 Avenue because of this, and push the hydraulic grade line in the storm sewer to the ground surface.

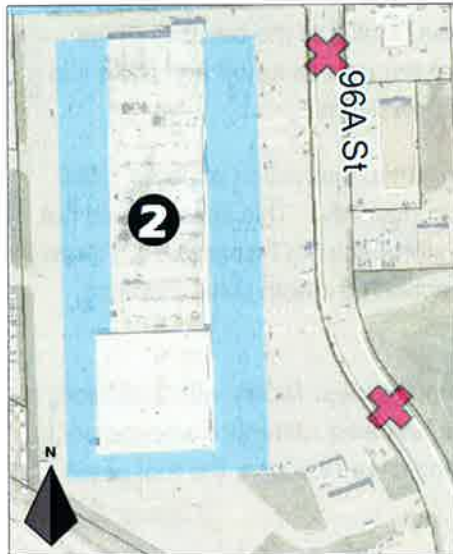
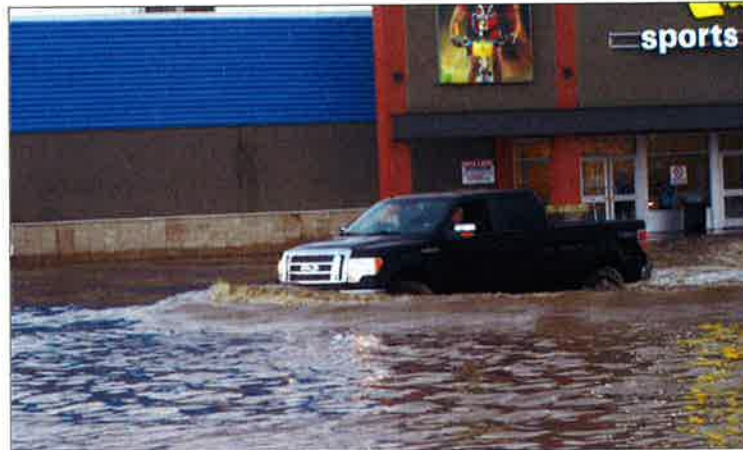
## 4.2 The Totem Mall

- The Totem Mall was constructed in a depression within the South-Central catchment with the parking lot generally graded towards the building.
- During extreme events, runoff escapes off adjacent roads at higher elevations and drains to the Totem Mall which exacerbates the problem.
- There is no overland drainage route from the site and stormwater relies exclusively on the piped system to be discharged from the property. The existing adjacent storm main along 96A Street is unable to accommodate the Totem Mall's peak 25-year runoff without any detentions measures.

The Totem Mall recently videoed their on-site drainage system; their drainage system appears to be in poor condition with damaged piping and reduced inlet capacities due to accumulated debris.

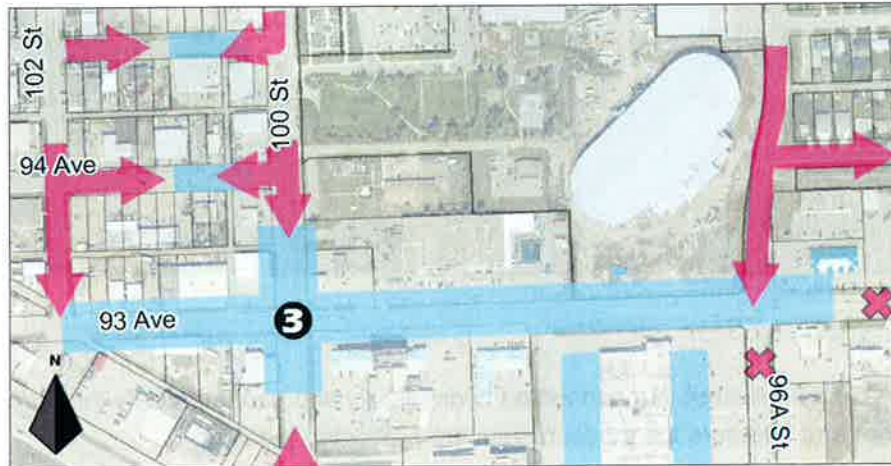
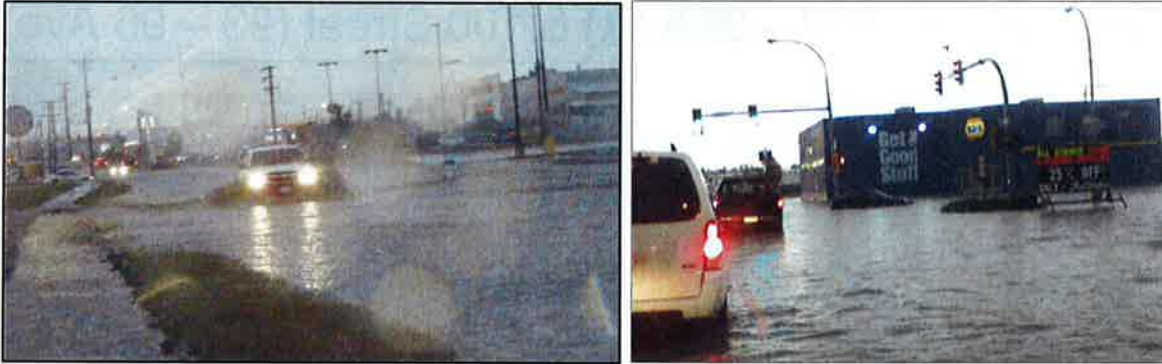
## 4.3 93 Avenue (102 – 96A St) & 100 Street (93 – 96 Ave)

- 93 Avenue is a 4 lane collector located within the FSJ Basin. The road has a flat grade with localized depressions along its length.
- Surface flows from 102 Street, 100 Street, and 96 Street all drain towards 93 Avenue.
- Because the storm sewer inlets and pipe capacities are limited, surface water ponding occurs at a number of locations along 93 Avenue, especially adjacent to the Totem Mall.
- The piped collection system does not extend along the entire length of the road.
- Upstream pipes collect water from higher elevations and generate head while under full conditions. Surcharging occurs and surface flow collects on 93 Avenue.
- During extreme events, when surface flooding becomes excessive, runoff can overflow from 93 Avenue to lower elevation areas such as the Totem Mall.

- The piped system does not have capacity to collect and transfer the rainfall experienced in a major storm event – surface flooding occurs.
- The natural drainage for this area flows in a SE direction. 100 Street is elevated relative to adjacent properties so it restricts overland flow from the west of 100 Street. This has created low areas prone to ponding such as 94 Avenue and 95 Avenue.
- Surface flow travelling south on 100 Street escapes the arterial road and ponds on lower adjacent avenues

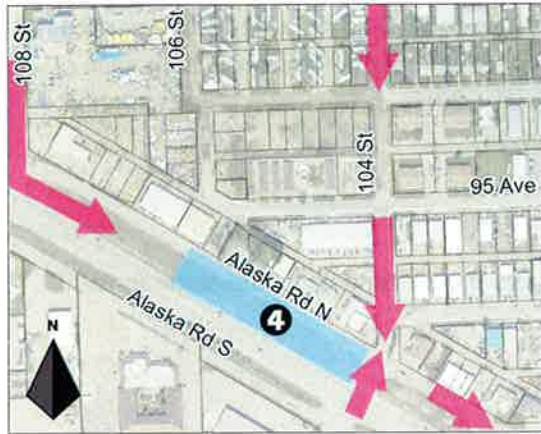
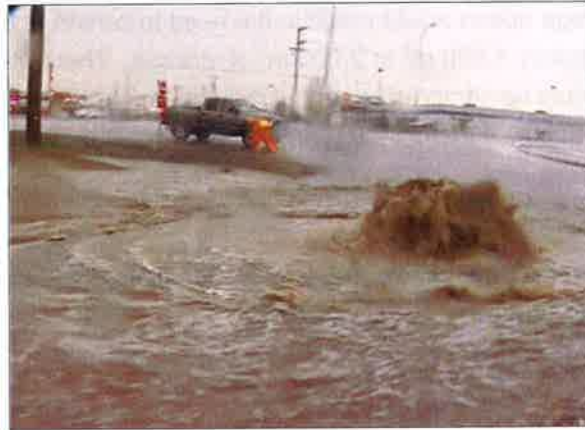
## 4.4 Alaska Road North (108 – 104 St)

- The existing piped system does not have capacity to collect the rainfall experienced in a major storm event therefore surface flooding is caused
- The natural surface drainage for this area flows in a SE direction. Since the Alaska Highway is elevated its approaches are also elevated; this confines overland flow between the 108 Street and 104 Street approaches (when pipe capacities are exceeded).
- Upstream pipes collect water from higher elevations and generate head while under full conditions. Surcharging occurs along Alaska Road North under high flow conditions.
- Because of surcharging, flow may spill towards 93 Avenue and further contribute to the problems there.

Extending the storm sewer trunk to this location relieves pressure on the capacity of the storm main located along Alaska Road South.

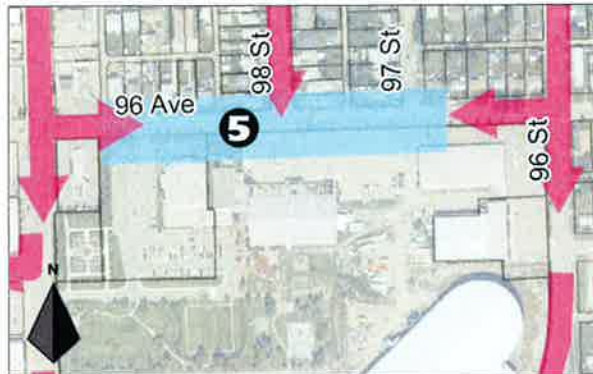
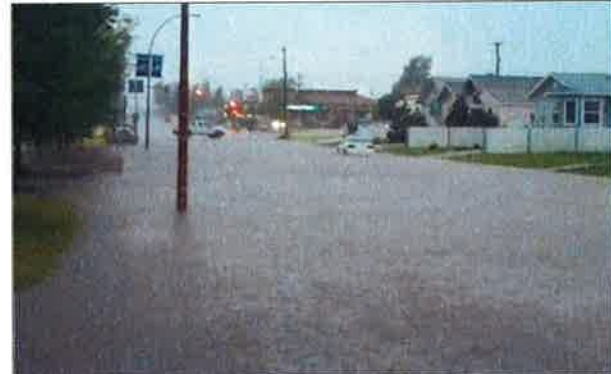
## 4.5 96 Avenue (100 – 98 St)

- There is a localized depression along 96 Avenue
- The current piped system cannot discharge peak flows fast enough and surface flooding begins.
- Upstream pipes along 98 Street collect water from higher elevations and generate head while under full conditions. Manholes/CBs may surcharge at 96 Avenue because of this.
- Surface flow escapes from adjacent higher elevated roads (100 Street and 96 Street) and drains to 96 Avenue.
- Surface flow collected on 98 Street and 97 Street drains directly to 96 Avenue.
- The original overland drainage path, which flowed in the southern direction, is obstructed by previous development.

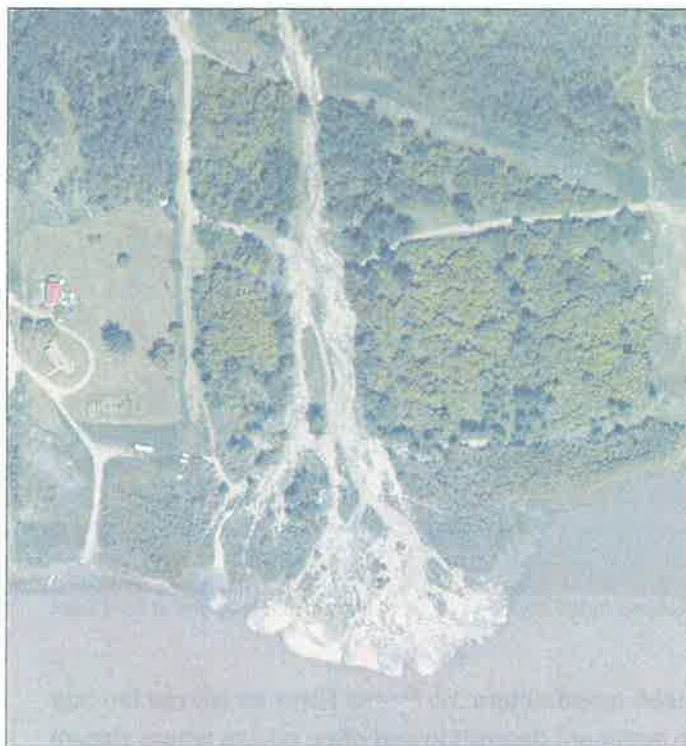
At the point of discharge where the Bouffieux Coulee runoff enters the Peace River an alluvial fan has been created. An alluvial fan is formed by built up sediment deposition and often occurs where stream flow emerges into a flatter plain. It is a good indicator of sediment transportation in the upstream stream flow. The current span of the alluvial fan spans approximately 200 m wide.

Figure 11 –A 2009 view of the alluvial fan near the Old Fort community. The sediment load of the alluvial fan expands into the Peace River.
