## City of Fort St. John Stormwater Masterplan

Phase 1

April 29, 2013

**RE: FINAL REPORT – STORMWATER MASTERPLAN – PHASE 1**

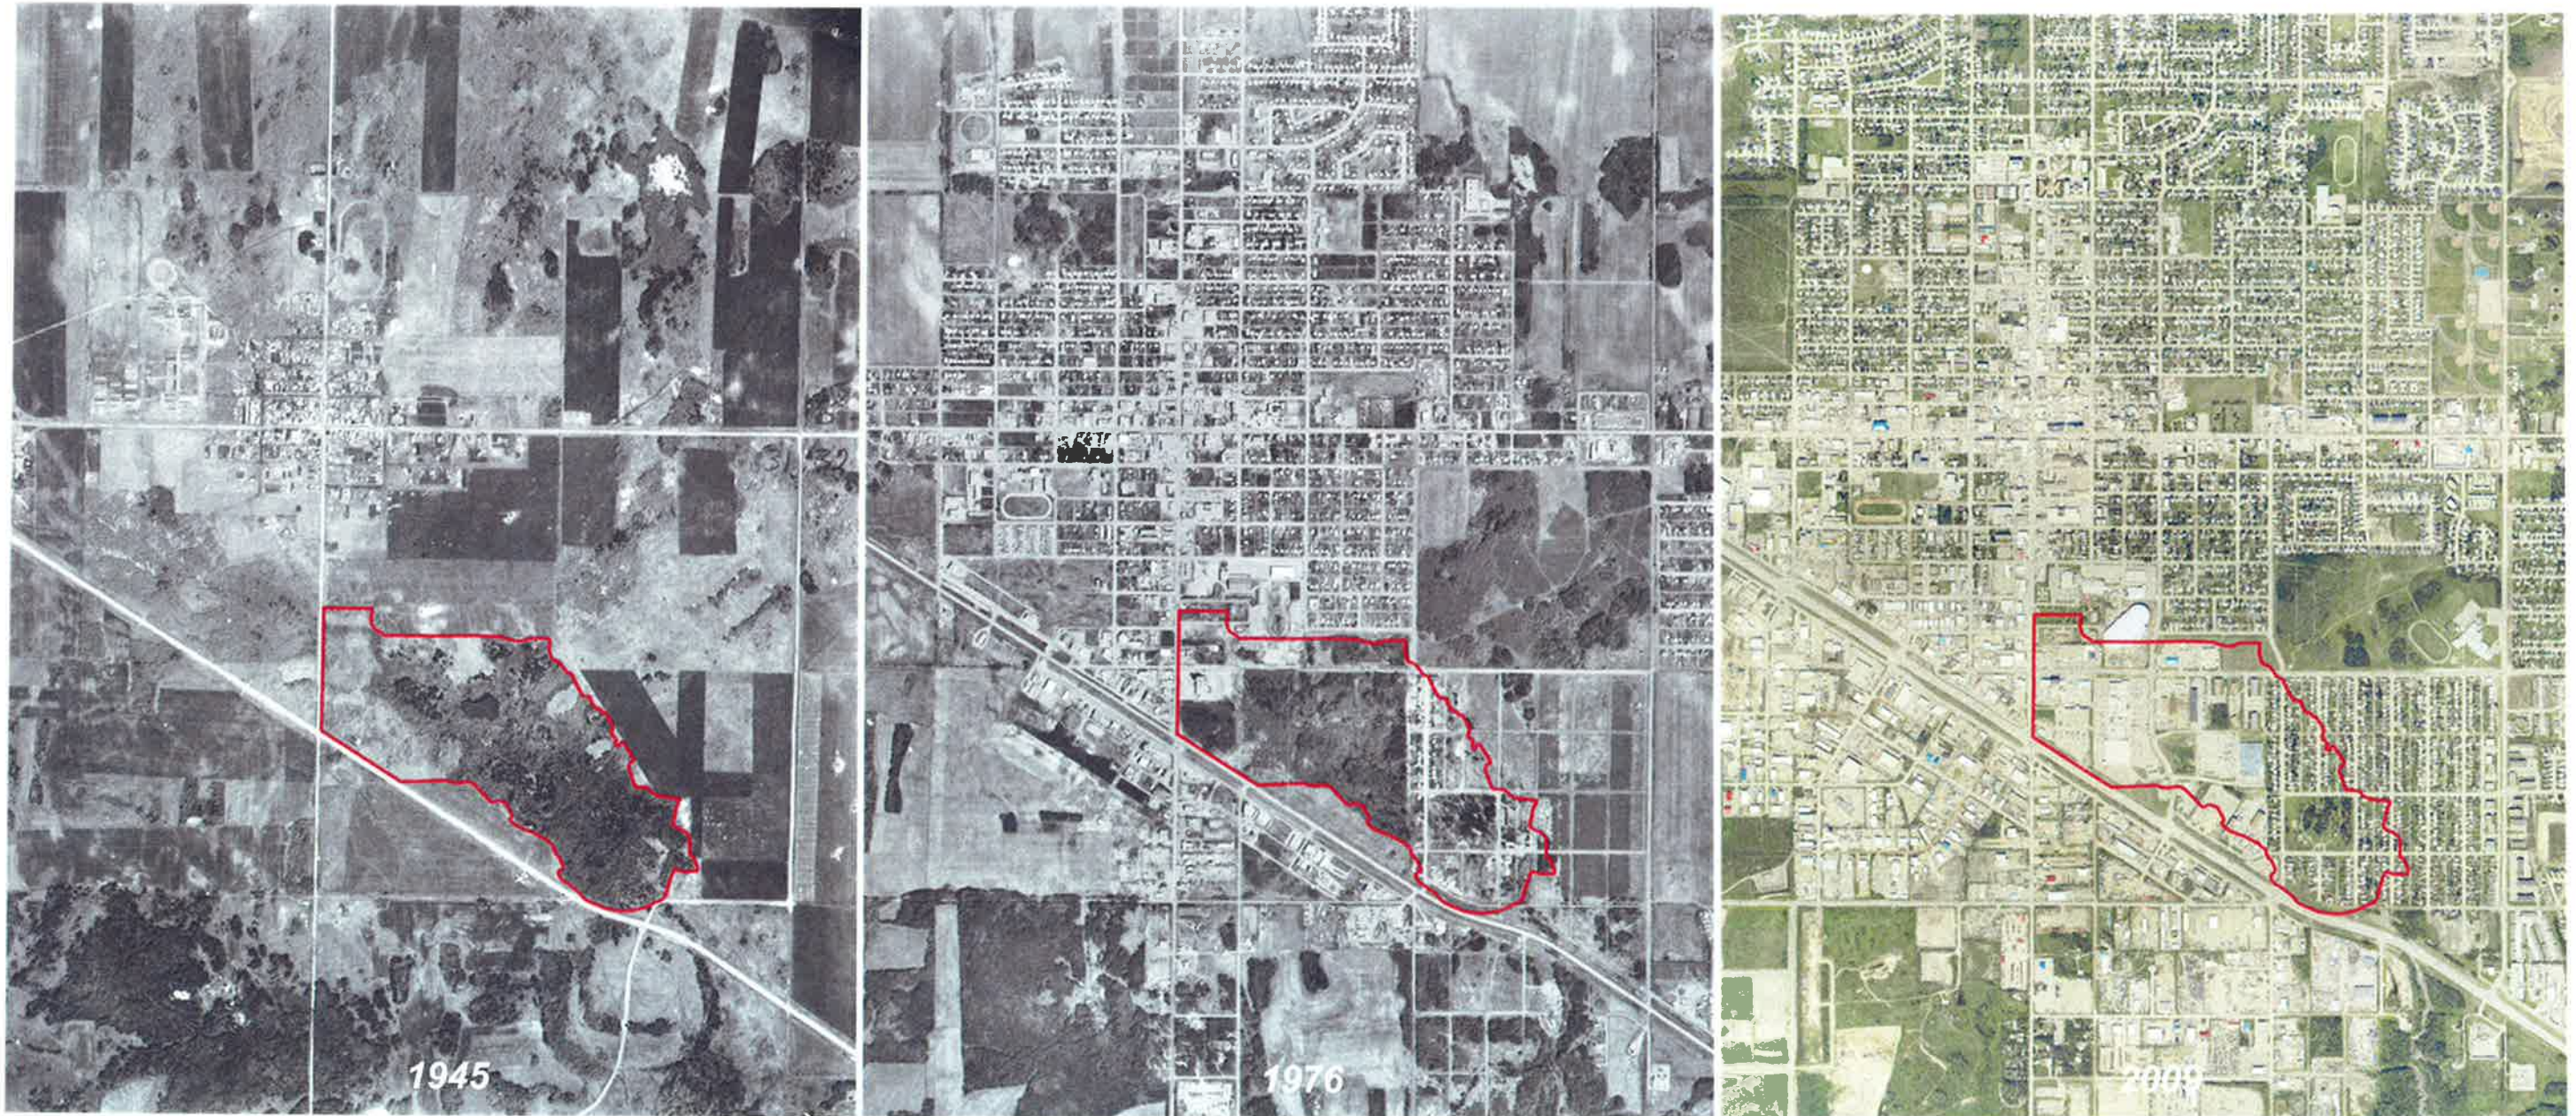
Prior to the development of current businesses, the FSJ Basin area was a natural depression filled with brush surrounded by agricultural lands (Figure 2 – 1945 air photo). It is assumed that the agricultural farmers of the 1940's did not clear land within the basin because of its poor drainage qualities. The City at this time was small and concentrated at the intersection of 100 Street and 100 Avenue. Other important characteristics of the 1945 air photo include 100 Street and the Alaska Highway surrounded by agricultural lands. The Alaska Highway even appears to have shifted alignment near the Bouffieux Coulee to avoid passing through the low-lying lands.

By 1976, 31 years later, Fort St. John had expanded in all directions (Figure 2 – 1976 air photo). The Matthew's Park development can be seen encroaching into the FSJ Basin but the land within the basin largely remained untouched. At this time the City begins to have notable development characteristics and many present day streets and avenues can be identified. 93 Avenue is constructed but likely did not have the drainage issues of today as runoff could still flow south to the low-lying lands within the FSJ Basin. Similarly, other areas within the South-Central catchment likely did not have drainage problems as the undeveloped FSJ Basin, with its large area, acted to attenuate the peak flows and slowly release them for discharge into the Bouffieux Coulee. The coulee at this time is filled with vegetation growth but shows slight erosion towards the southern photo edge.

A view of present day Fort St. John (Figure 2 – 2009 air photo) resembles the 1976 air photo but has significant changes in regards to drainage in the South-Central catchment including:

FIGURE 2. COMPARISON OF AIRPHOTOS OF THE FSJ BASIN FROM 1945, 1976, TO THE CURRENT DAY (2009 IMAGE). HISTORICALLY THE FSJ BASIN WAS A NATURAL DEPRESSION WITH BRUSH, SURROUNDED BY AGRICULTURE LAND, AND NATURALLY DRAINED BY SURFACE INTO THE BOUFFIOUX COULEE.

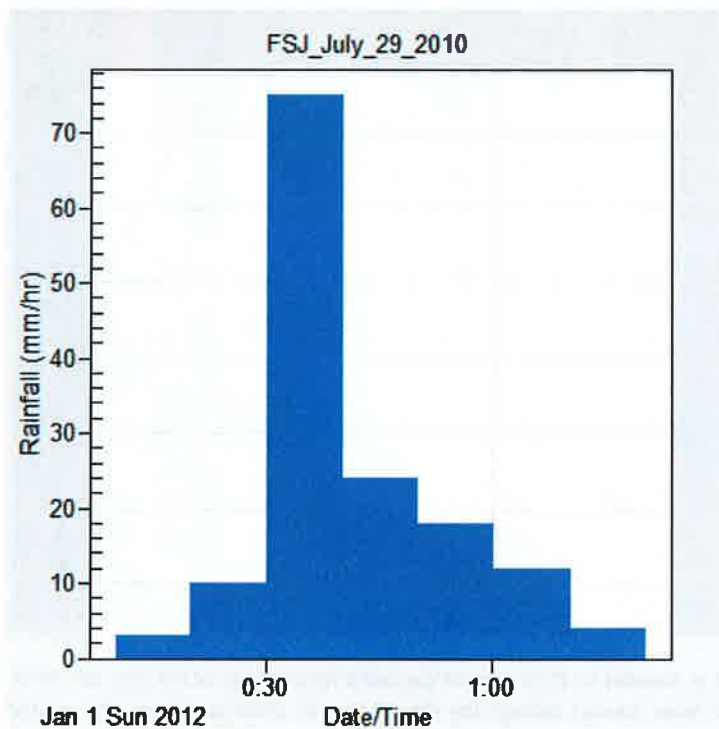
An alternative publically accessible data source available is radar data collected from Environment Canada’s Spirit River monitoring station. Using radar images at 10 minute intervals and estimating the rainfall intensity, a rainfall hyetograph for the July 29, 2010 event was constructed (Figure 4). This amounted to approximately 24.8 mm of rain over a one hour period.

Figure 4. Rainfall hyetograph of the July 29, 2010 event constructed using radar data collected from Environment Canada’s Spirit River monitoring station. This storm has a short duration and a high intensity.

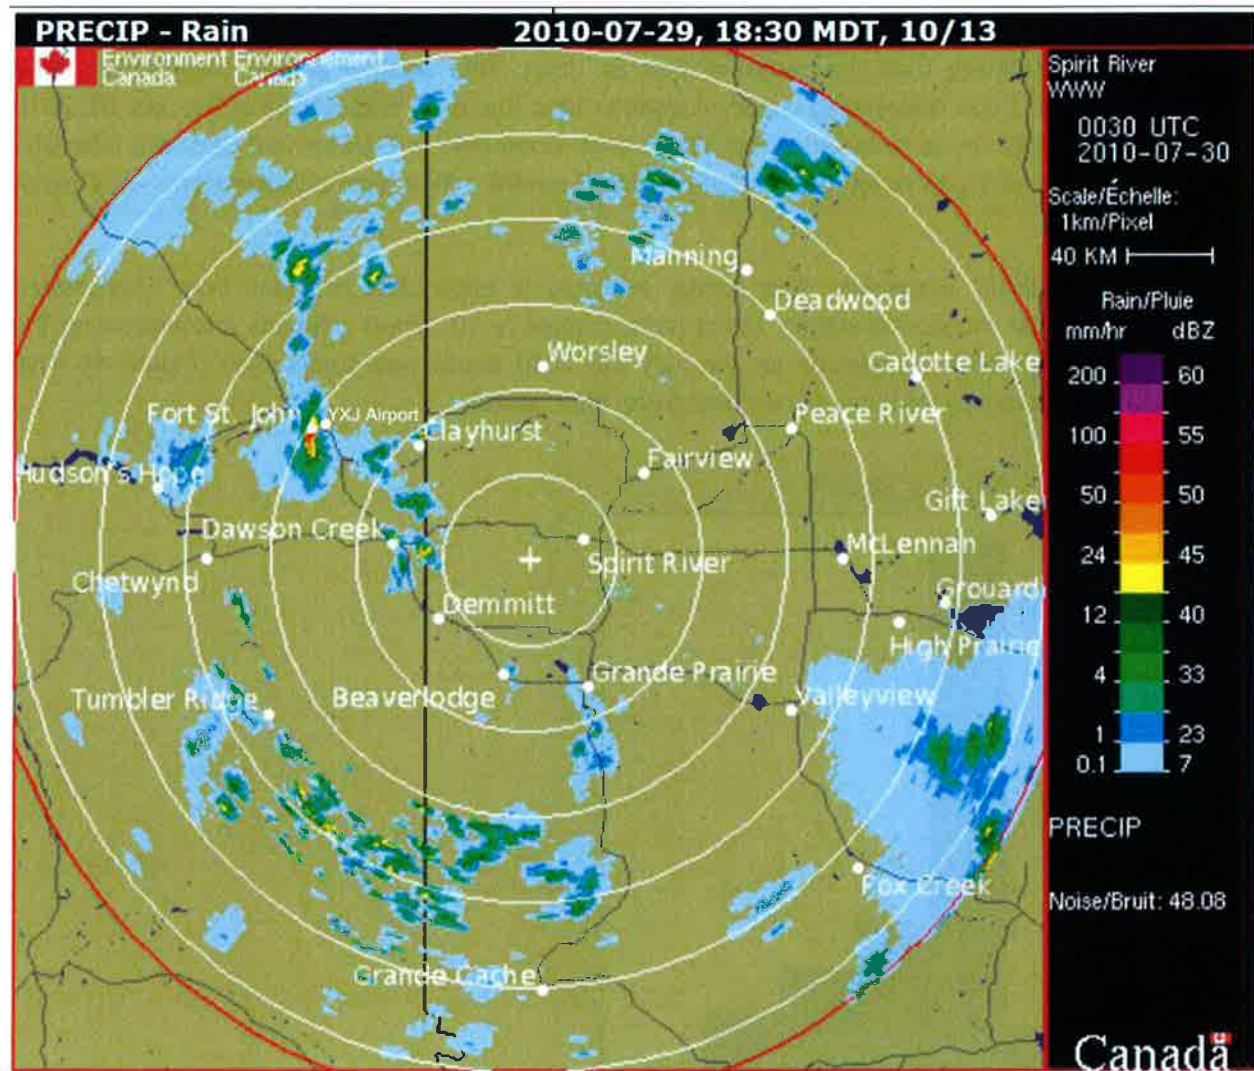
The aerial extents of high intensity storms can have very localized effects. Peak rainfall rates within a storm event typically occur very rapidly over a concentrated area. Radar images of the July 29, 2010 event revealed that the storm skirts the Fort St. John Airport while the highest intensity passes through the centre of the City (Figure 5). This confirms why the City of Fort St. John experienced high quantities of rain while the nearby airport did not.

Figure 5. The Fort St. John Airport (labelled YXJ Airport) is inserted on Environment Canada's radar image of the July 29, 2010. Note the high intensity of the storm, indicated in the red hues, passes through the City of Fort St. John but misses the rainfall monitoring station at the YXJ Airport. The radar images used were collected from Environment Canada's Spirit River weather station.

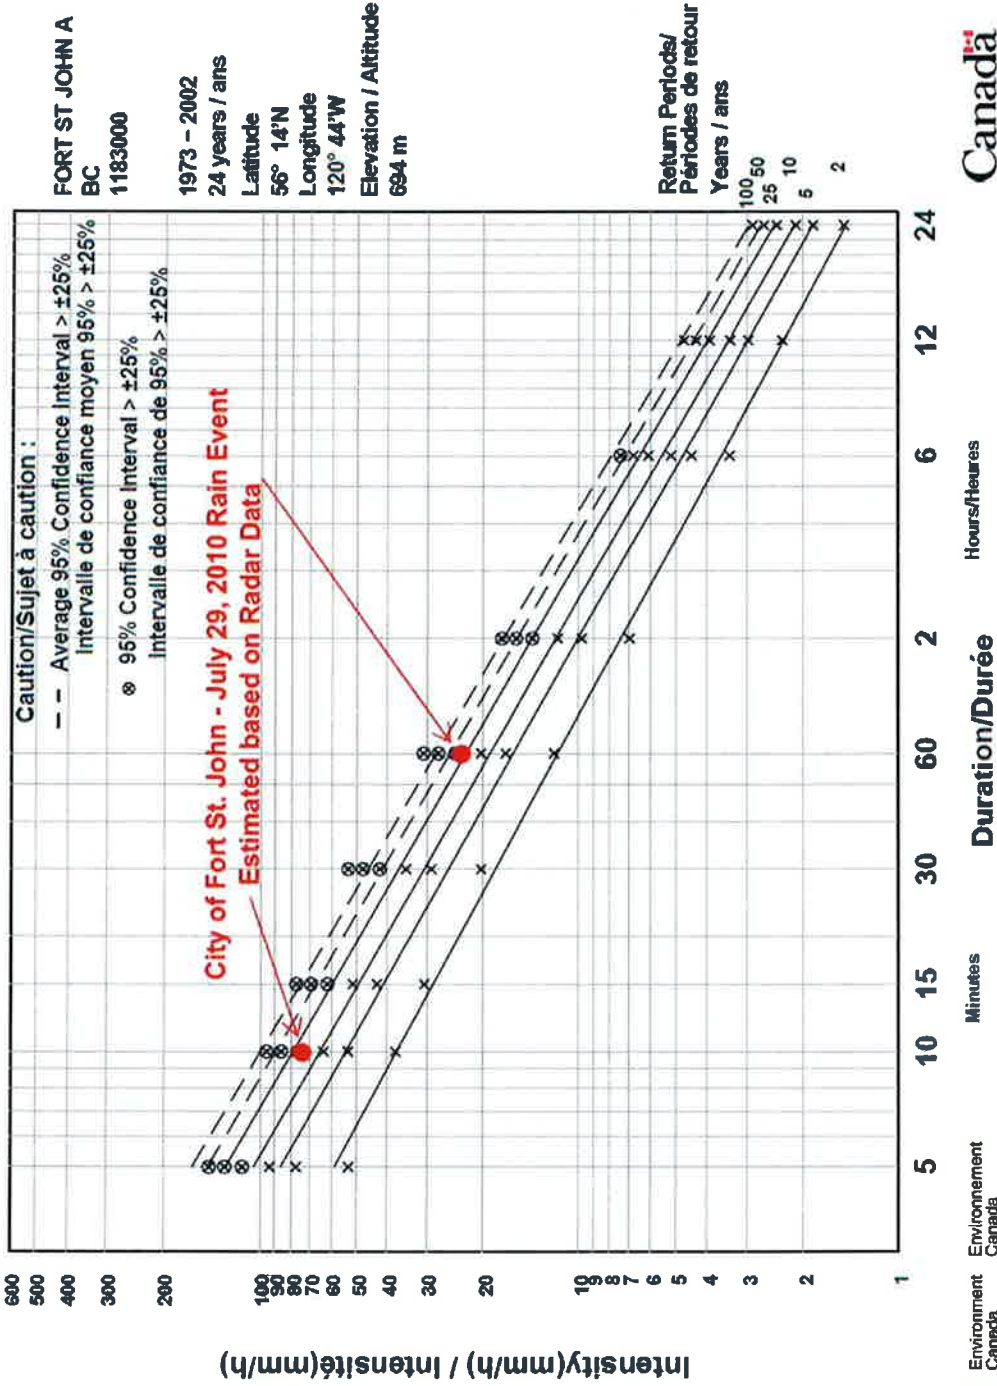
With the information gathered, the peak intensities during a ten minute and one hour period are plotted on the Environment Canada IDF Curve for Fort St. John (Figure 6). Although projected with uncertainty, it appears the July 29, 2010 rain event was around a 25-year storm.

Figure 6 – IDF curve supplied for Fort St. John by Environment Canada. Two estimated plots of the July 29, 2010 rain event are plotted as solid red circles

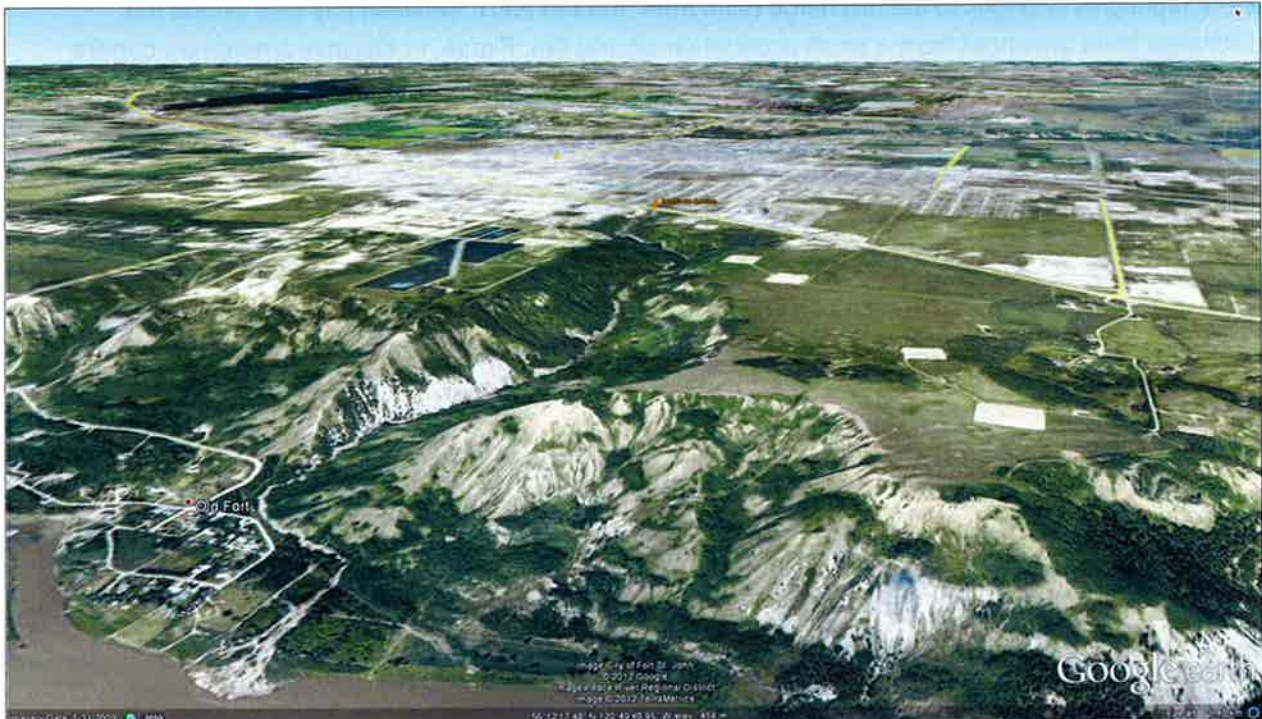
After exiting the steep walls of the coulee runoff flows along a channelized path through the terrace shared with the Old Fort community. Runoff from the Bouffieux Coulee continues until it discharges in the Peace River (Figure 10).

Figure 10 – Overview of the Bouffieux Coulee extents as it captures runoff from Fort St. John to its discharge point at the Peace River (Google Earth).

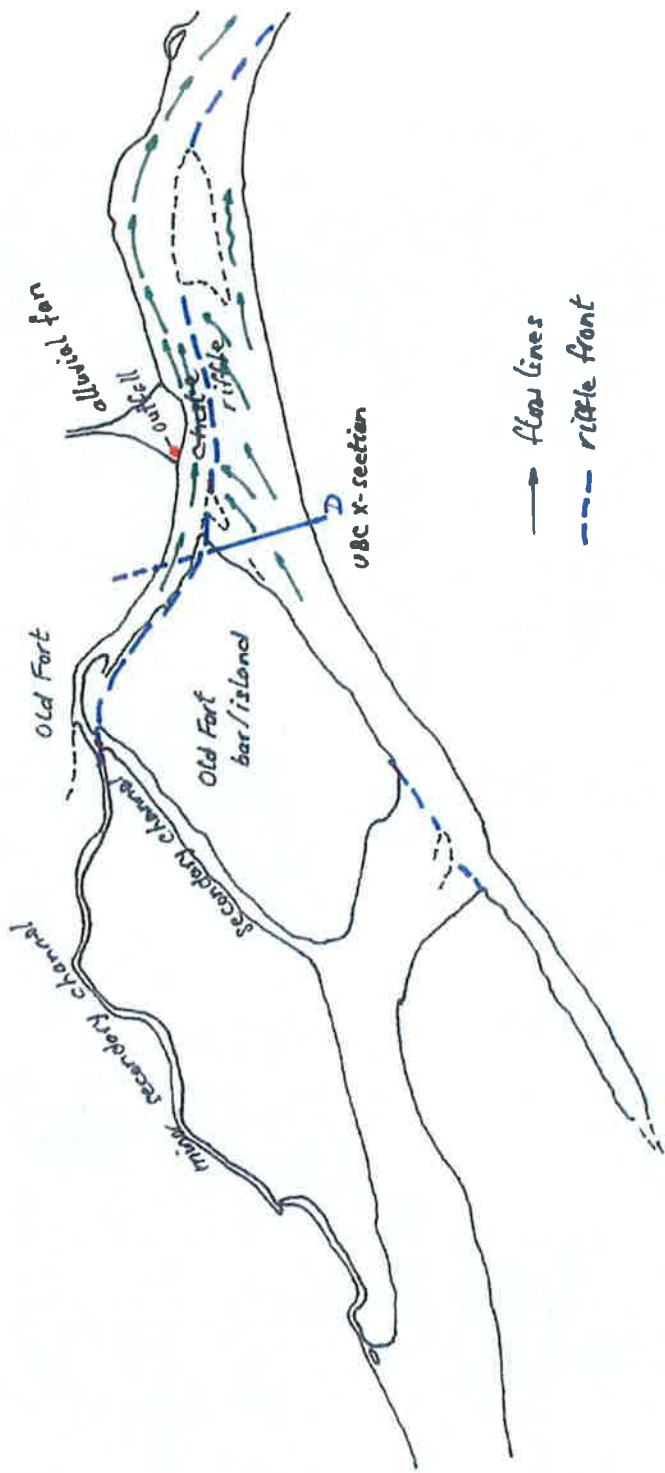
Figure 1 is a sketch map of the study site. At this site, a historic secondary channel that flowed behind an island at Old Fort rejoins the main channel. The main river flows on the south side of the island, and then crosses a diagonal riffle that extends downstream from the bar/island in front of Old Fort to impinge on the right bank at a major bend downstream. The major bar/island in fact continues the riffle upstream to impinge on the left bank near the confluence of a minor secondary channel that flows behind an older island. Long diagonal riffles, with superposed bars and/or islands are a common feature in gravel-bed channels like Peace River. The deep channel that collects flow below the riffle is known as a "chute". The outfall was originally positioned in this chute.

Figure 1. Sketch of the principal features of Peace River in the vicinity of Old Fort.

The outfall was installed after regulation, when the current flow regime of the river was established. The outfall site, on the toe of an active alluvial fan, was not well chosen. Extension of the pipe in its current location would leave it exposed to reburial, or to effects of sedimentation that are difficult to predict should the fan eventually grow out to approach the riffle in mid-channel. A superior alternative would be to move the outfall point downstream, away from the fan, where fast water still persists in the left-bank chute channel. In that vicinity, where the bulk of the main river flow is directed toward the left bank near the downstream end of the riffle, the channel is apt to remain stable for a long time under the current or practically foreseeable flow regimes. Since I have had no opportunity to conduct site investigations, a more detailed recommendation cannot be offered.

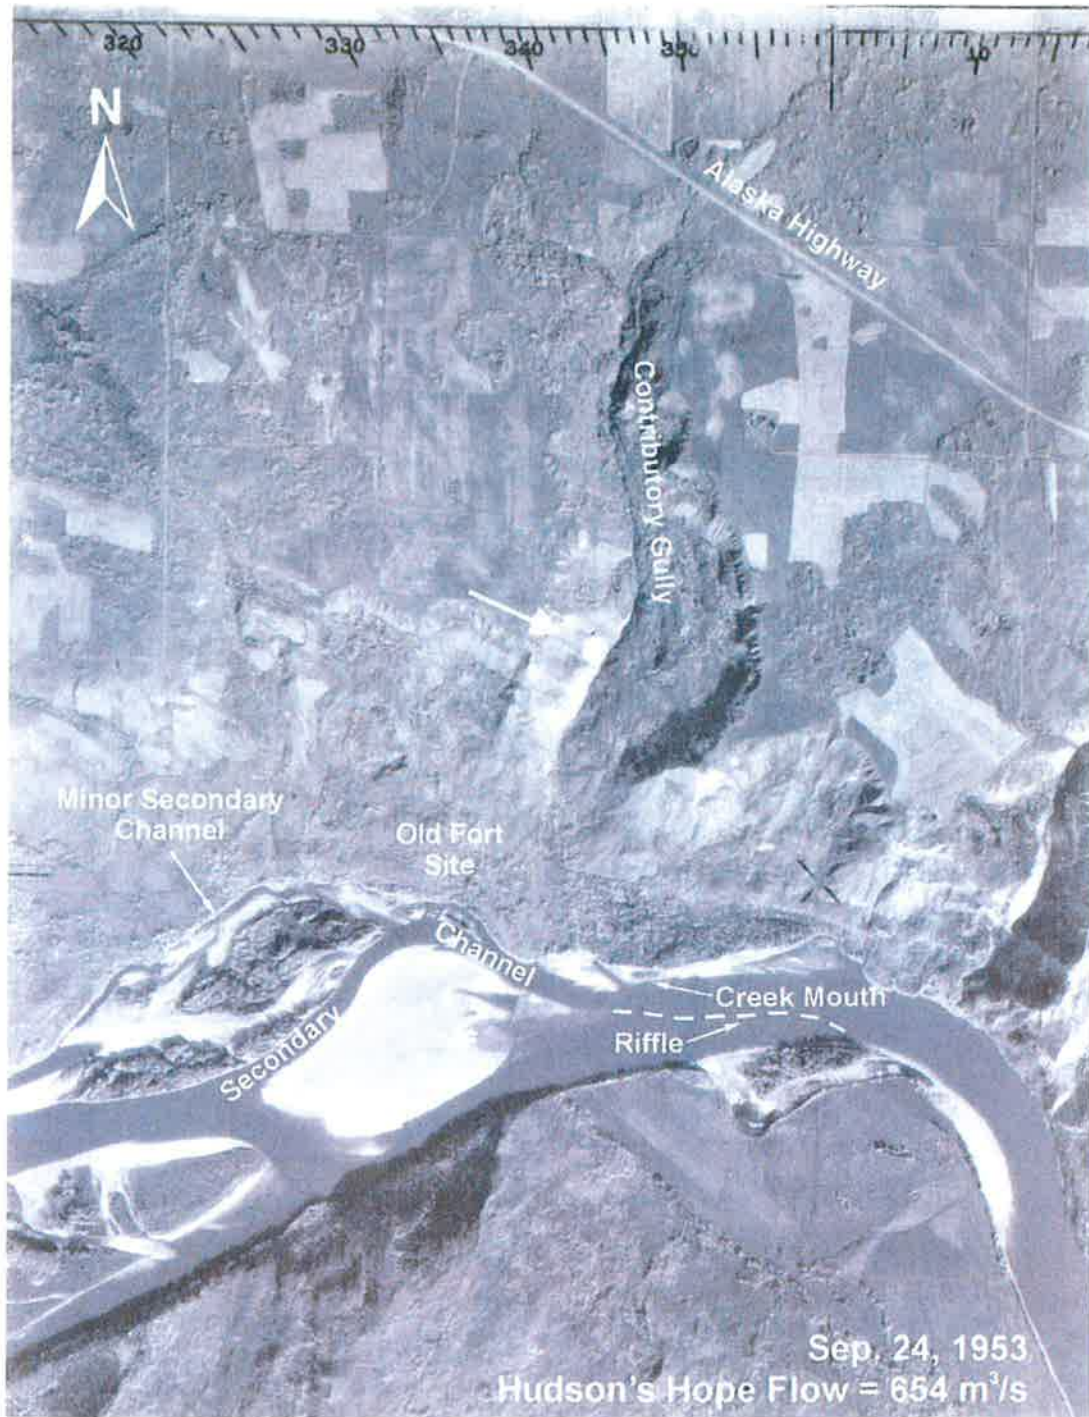
The development of the channel in the vicinity of Old Fort can be followed on air photography over a period of 50 years (figures 2-6). Figure 2 shows the channel in 1953, before regulation. The gross appearance is not much different than we see today, although it appears that the "secondary channel" flowing behind the Old Fort bar was relatively more prominent than it is today (in comparing the photos, the different flow levels should be recognised). A subsidiary bar in the right bank channel near the head of the island indicates that the contemporary main channel was then quite shallow.

Figure 2 shows the outlet of the gully channel in 1953 cutting a substantial channel through the left-bank gravel deposits. This configuration was still present in 1967, but the stream outlet appears to have moved downstream and to be developing a small gravel fan across the inshore riverbed. (The tributary outlet may have been relocated as part of the property development in the Old Fort subdivision, and it appears as if the former channelway formed the initial boat basin at the site). By 1977, the fan was well-established and it has become more prominent since. In the 1986 photograph the fan is relatively prominent, but does not protrude into the occupied channel (the photo was taken at very low flow), whereas by 2001, the fan protruded prominently into the channel (see, in particular, figure 19 in Urban Systems, Ltd., Report to the City of Fort St. John, Appendix E).

Figure 2. Vertical air photo of Peace River near Old Fort. Part of BC1777/48. The scales of this and the following figures (to figure 5) have been adjusted to be similar. However, they are not identical.

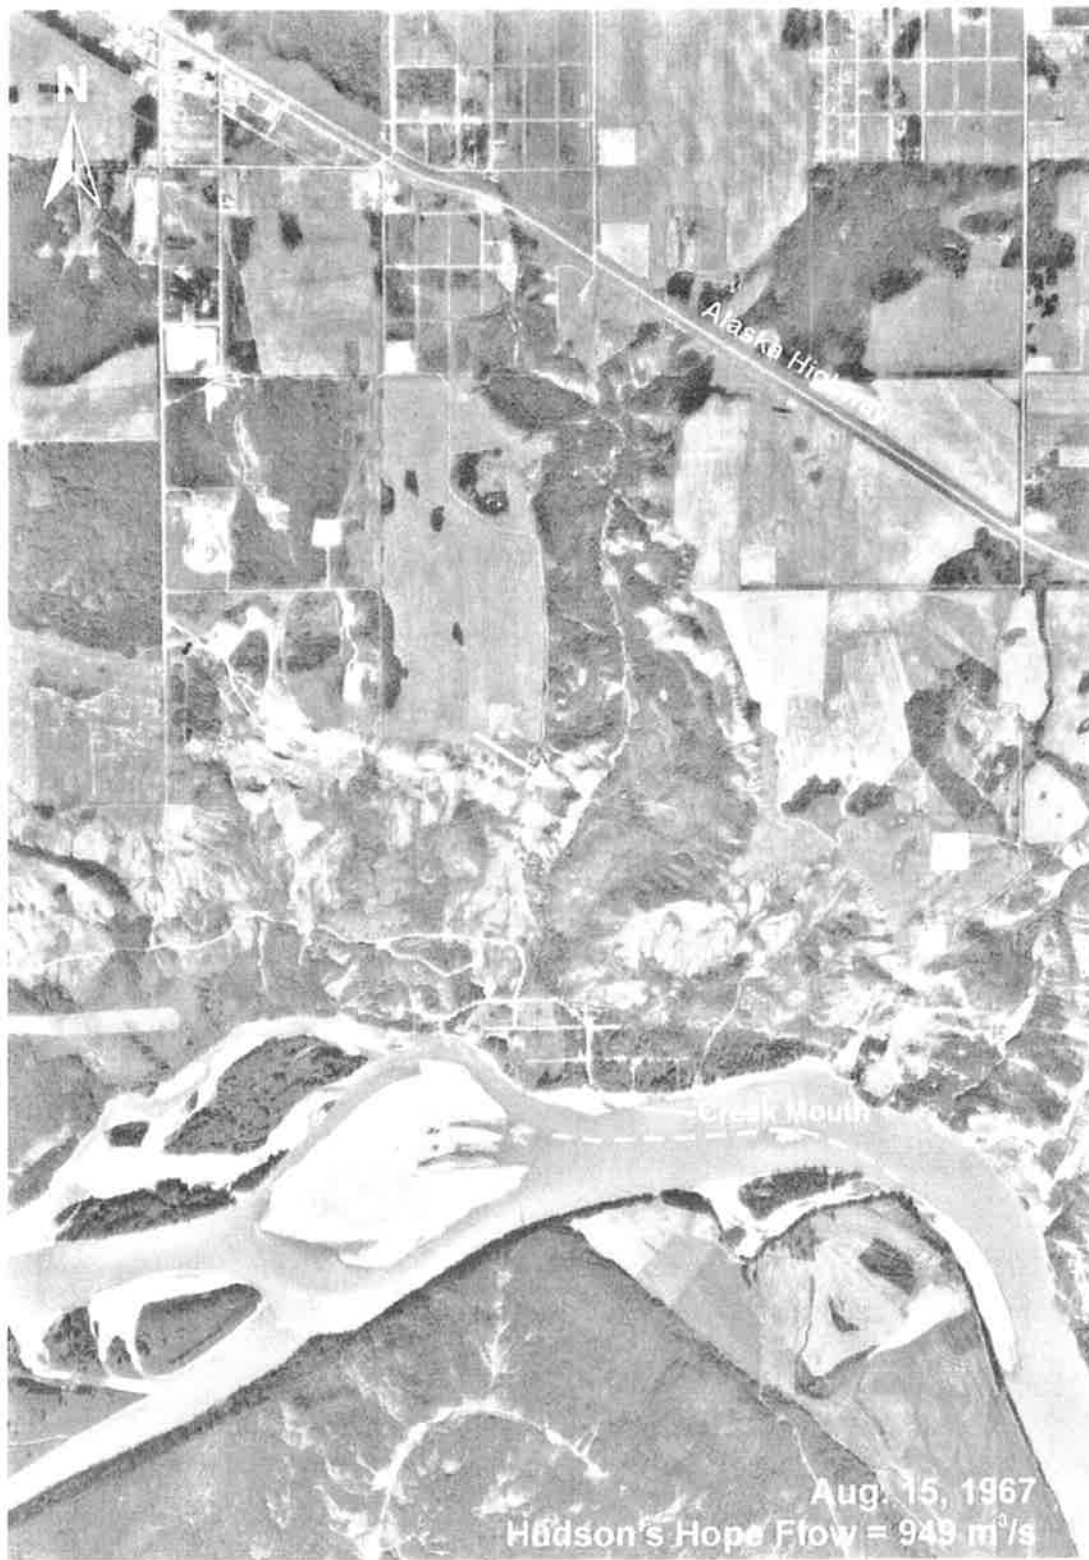
By 1967 (immediately before the inception of flow regulation: figure 3) there is evidence of sedimentation at the confluence of the secondary channel with the minor secondary channel at the north tip of the major bar, directly in front of Old Fort, and it appears that the right bank channel of Peace River has become the dominant channel. There is also evidence of fresh sedimentation on the main riffle downstream, near the right bank and the bend. However, there are no other major changes evident. There are few further changes in the bar configuration in either 1977 (figure 4) or 1986 (figure 5). However, during this period vegetation became established on the bar and prograded down the left bank downstream from Old Fort since flows no longer overtopped these areas on a regular basis. The highest water during these years characteristically occurred as the result of frazil ice jams during winter.

Figure 3. Peace River near Old Fort. Part of BC5269/007.

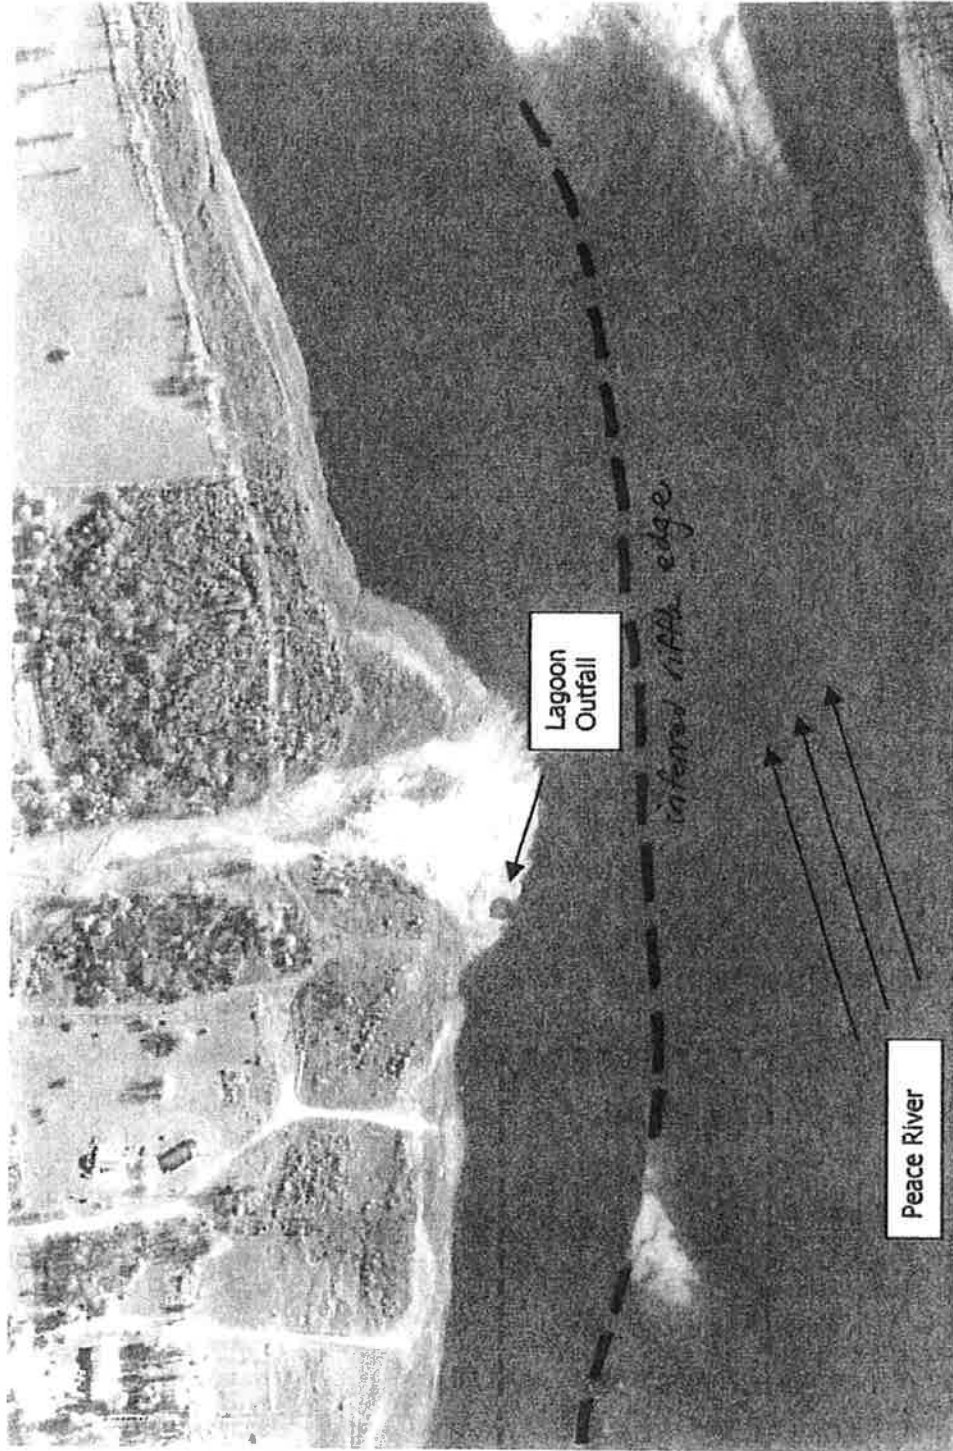
The 1996 photography was taken during a major dam release flow and shows few details of the riverbed morphology. Figure 6 is a recent satellite photograph (part of Figure 17: Appendix E in the draft report of Urban Systems, Ltd. to the City of Fort St. John, taken October, 2001). Again, overall configuration has not changed significantly, although it appears as if there has

Figure 6. Left bank of Peace River immediately downstream from Old Fort. Satellite view of October, 2001 (from Urban Systems, Ltd.)
